Chapter Two

Regional Erosion and Revegetation Assessment - Task Two

Erosion and Revegetation Site Analyses

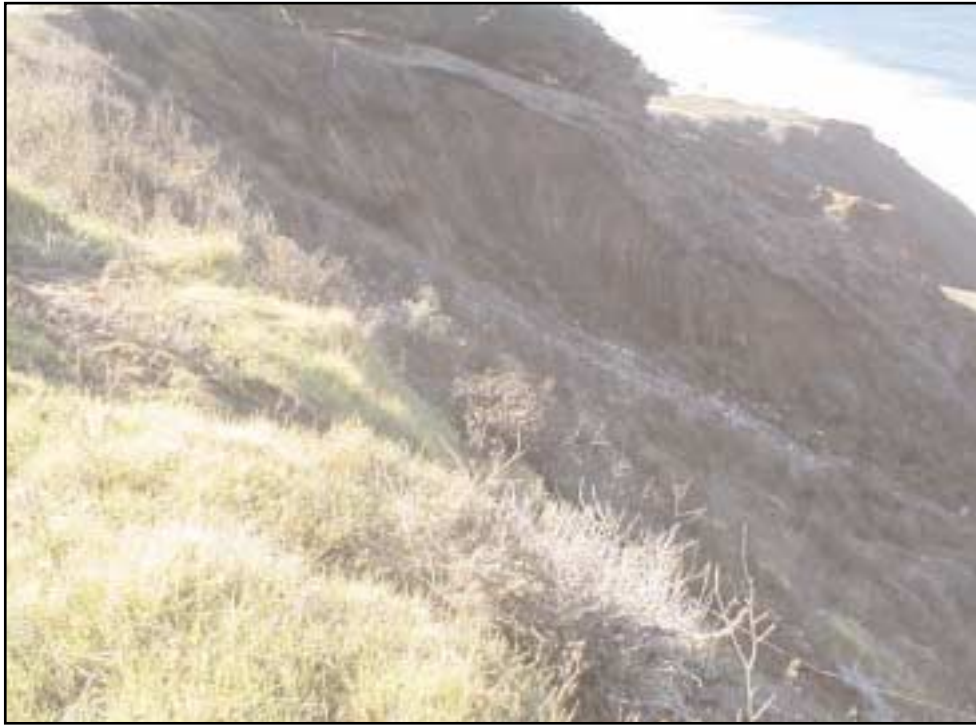
Figure 2.5 Detail of slope from road looking south.

Site # 4 Little Sur South					
Site Objective	Erosion Control/ Revegetation	Bio-Engineering Applications	Restoration Recommendations		
			Site Maintenance Actions	Seed and Revegetation	Monitoring Actions
Site Stabilization			Redirect surface water flow across highway	<i>Lupinus albifrons, Festuca rubra, Erigeron glaucus</i>	
			Rill and gully erosion repair downslope		Is site stable?
Revegetation	Hydroseed south flank of downslope		Once surface water flow redirected, hydroseed	Plant willow at toe of downslope	Is site vegetated with a diversity of species present?
	Plant cypress trees to stabilize soils				
Site Maintenance	Downslope exotic species present: kikuya grass		Control of exotic species	Vegetate berms with low growing annuals or perennial grasses	Monitor cracks in pavement
					Are exotic invasive plant species less than 10% of site coverage?
Project Reporting	No erosion present		Site maintenance actions recorded	Submittals review/ specified materials at hand	Project completed, success criteria achieved-Final Recommendations

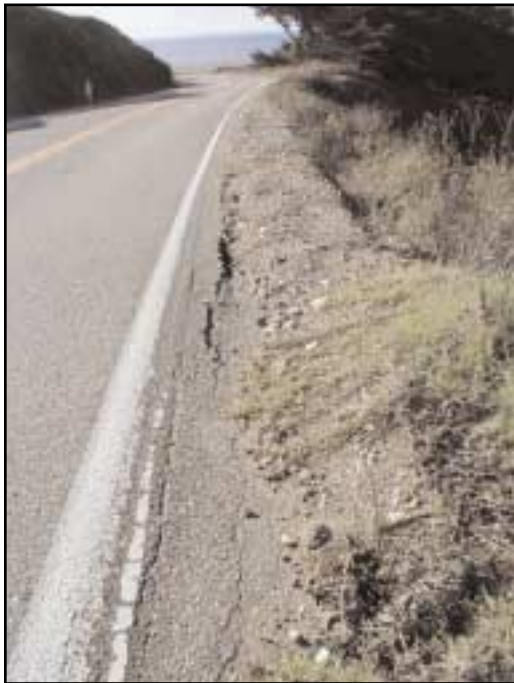
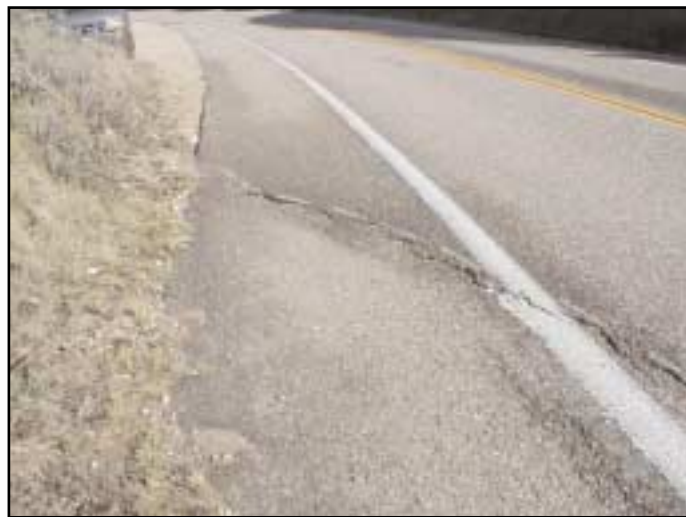
Figure 2.6. Cracks evident in pavement need monitoring.

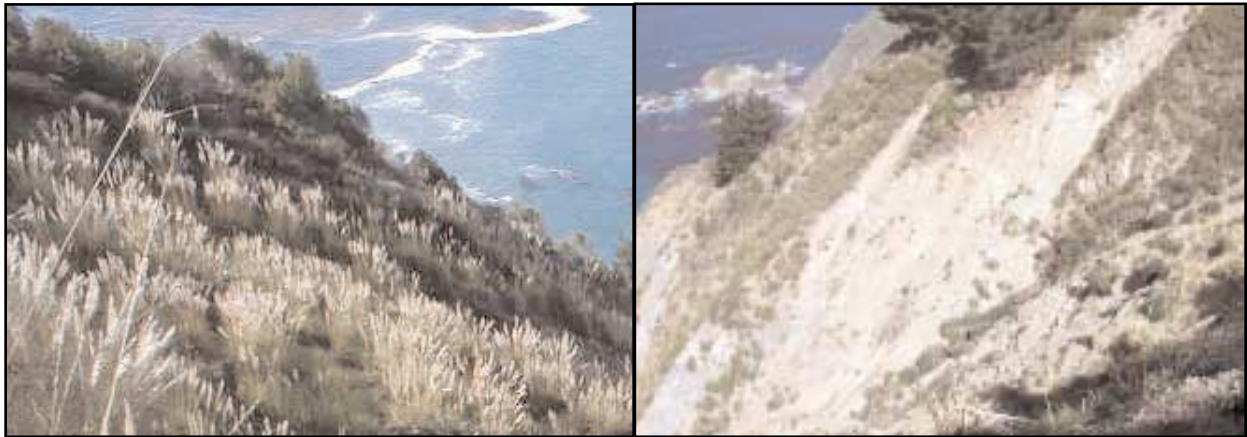
Figure 2.8. Picture on left shows the Pampas grass growing on site, and the picture on the right shows bare surface soil that needs to be stabilized.

Site #5 Sycamore Draw					
Restoration Recommendations					
Site Objective	Erosion Control/ Revegetation	Bio-Engineering Applications	Site Maintenance Actions	Seed and Revegetation	Monitoring Actions
Site Stabilization			Rill and gully erosion repaired		Is site stable?
	Anchor toe of slope where slippage occurs downslope		Control surface water flow from upslope side of highway-prevent discharge under guard rail through non-controlled structure	<i>Elymus glaucus</i> , <i>Eriophyllum</i> <i>steachadifloium</i> , <i>Eriogonum</i> <i>parvifolium</i> , <i>Bromus</i> <i>carinatus</i> , <i>Lotus purshianus</i>	Monitor headcuts of slope under guard rail.
Revegetation		Willow pole cuttings in seeps and springs downslope		Hydroseed upslope. Apply straw downslope to protect surface.	Is site revegetated with a diversity of species present?
Site Maintenance	Stabilize cut on downslope of road		Exotic control: Fennel, Pampas grass, Genista downslope		Are all non-biodegradable elements removed?

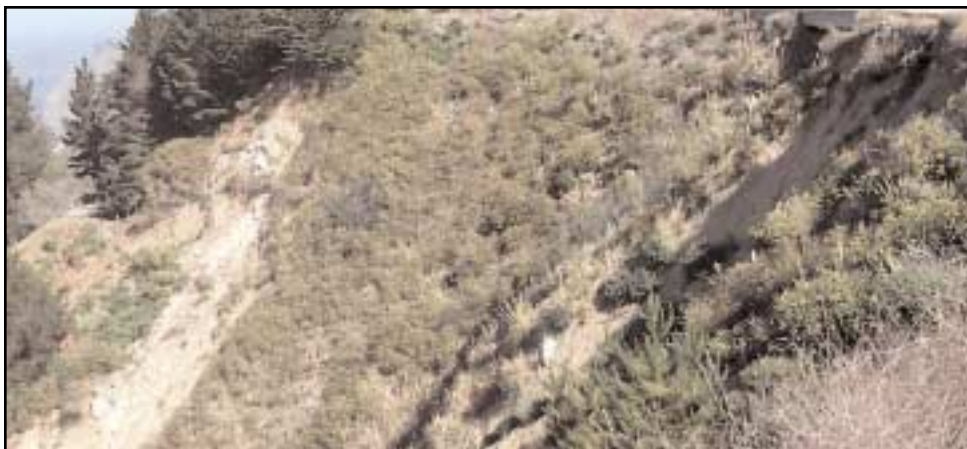
Figure 2.9.
Long shot looking north.

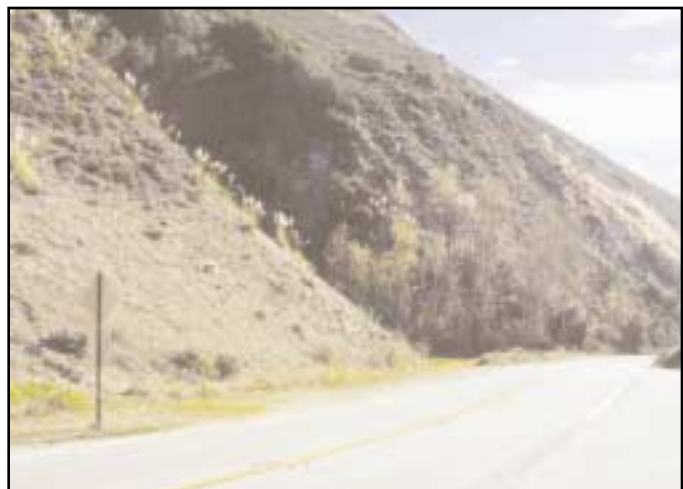
Figure 2.10. View of upslope showing pampas grass and bare soil.

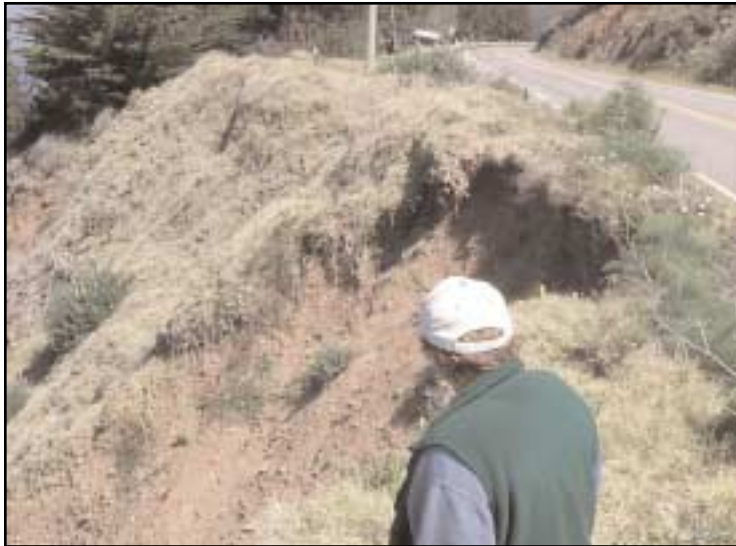
Caltrans Erosion Site Analyses		Rat Creek					
SLO County Line Mile Post Marker		30.2					
Photo-Reference Number		2-01, 2-02					
Site Conditions		slumping downslope, road bank failure					
Habitat Type		Central Coast Scrub					
Soil Type		Decomposed granite					
Slope		50-60%					
Aspect		Southwest					
Sensitive habitat present		Smith's blue					
Regional and Neighboring Property Owners		Jack O'Neil, Big Creek Reserve					
Potential Occurance of Rare Plant and Animal Species							
Smith's blue butterfly							
Eriogonum parvifolium							
Exotic Species Present (threat)							
Pennisetum clandestinum, Foeniculum vulgare, Genista monspessulana							
Potential Occurance of Cultural Artifacts							
none							
		Importance		Urgency		Trend	
<u>POTENTIAL FOR EROSION EVENT</u>		<u>(rank 1-10)</u>		<u>up slope</u>	<u>down slope</u>	<u>up slope</u>	<u>down slope</u>
Erosion Hazard		10	3	0	3	0	3
Potential slope failure		10	0	0	1	0	3

Figure 2.12. Pictures showing bare unstable soil and pavement cracks. Surface water flow may be adding to erosion problems.

Site Objective	Revegetation	Applications	Actions	Revegetation
Site Stabilization			Redirect water flow from upslope side of highway to control structure Rill and gully erosion repaired downslope	<i>Salix stiche</i> <i>Eriophylla</i> <i>staechadifolia</i> <i>Eriogonum parviflorum</i> <i>Melica imrayana</i>
Revegetation	Hydroseed upslope with perennial mix		After kikuya grass controlled, hydroseed downslope	Hydroseed upslope perennial
Site Maintenance			Control exotic species- Pampas grass, fennel, and kikuya grass	
Project Reporting	No erosion present		Site maintenance actions recorded	Submittals re specified materials hand

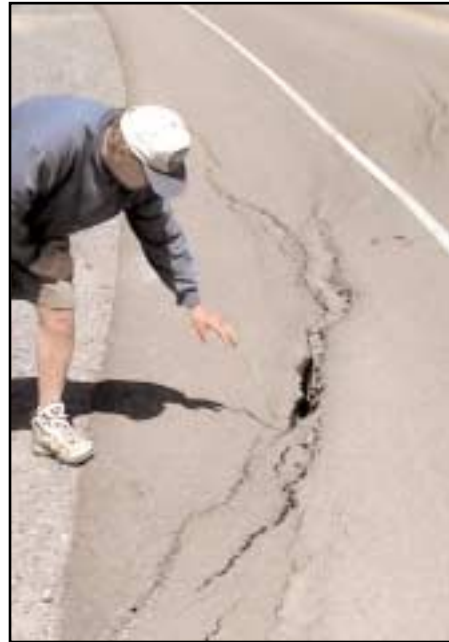
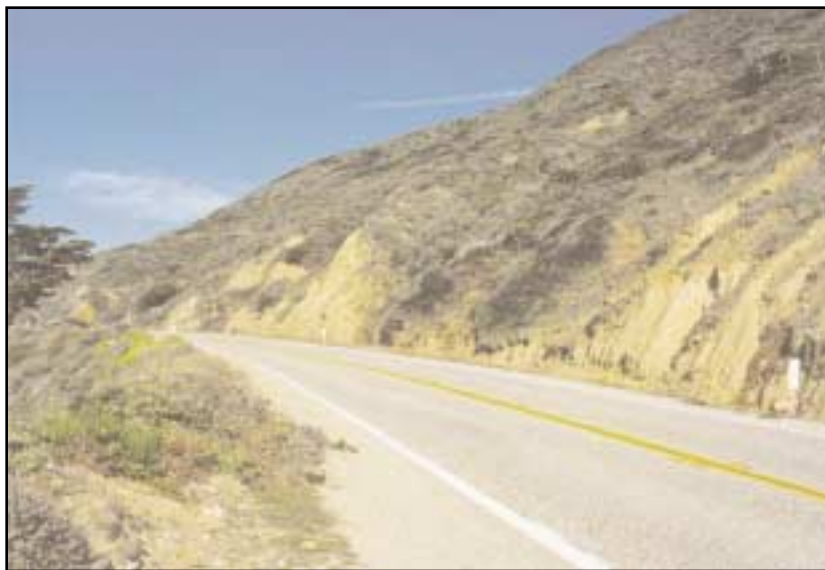
Figure 2.13. Long-shot looking north showing up slope.

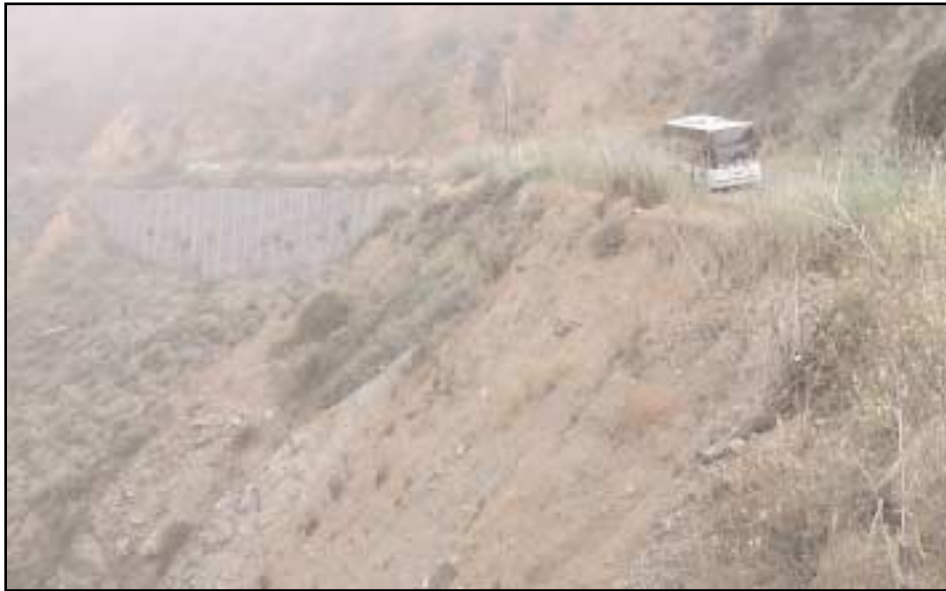
Figure 2.15.
Picture looking
north showing
sidecast with
no vegetation
present.

Site # 9 Vista Point-South of Big Creek					
Site Objective	Restoration Recommendations				
	Erosion Control/ Revegetation	Bio-Engineering Applications	Site Maintenance Actions	Seed and Revegetation	Monitoring Actions
Site Stabilization			Erosion control gullies and rills repaired	<i>Mimulus auranticus</i> , <i>Ceanothus thrysiflorus</i> , <i>Artemisia californica</i> , <i>Briklia californica</i> , <i>Stachys bulata</i>	Site stabilized, erosion present?
	Site requires permanent revegetation				
Revegetation			Reseeding, planting as required - Hydroseed downslope	Revegetate with permanent vegetation on berms	Is site revegetated, species diversity present?
Site Maintenance	Exotic species present: Pampas grass- fennel		Control of exotic species		Weeds controlled, exotic species less than 10% cover
					Non bio-degradable items removed
					Are exotic invasive plant species less than 10% of site coverage?

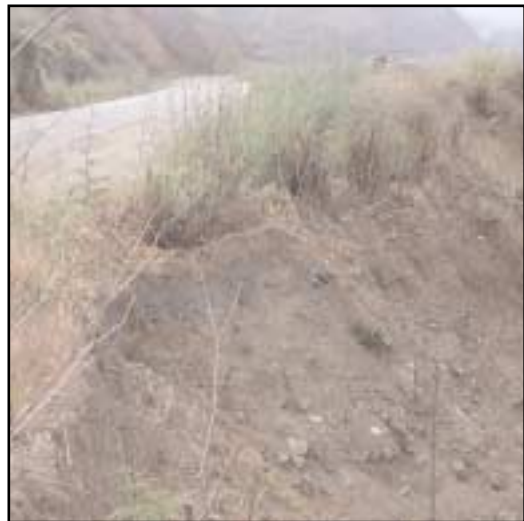
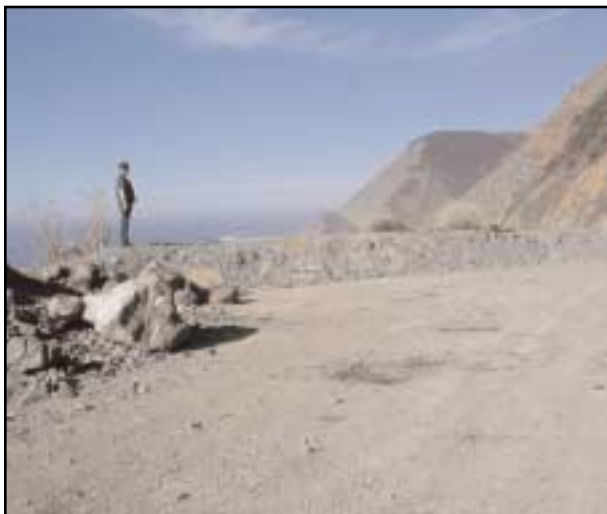
Figure 2.16. Picture
showing bare soils and
invasive weeds at the
highway edge, looking
south.

Figure 2.17. View of
unvegetated berm.

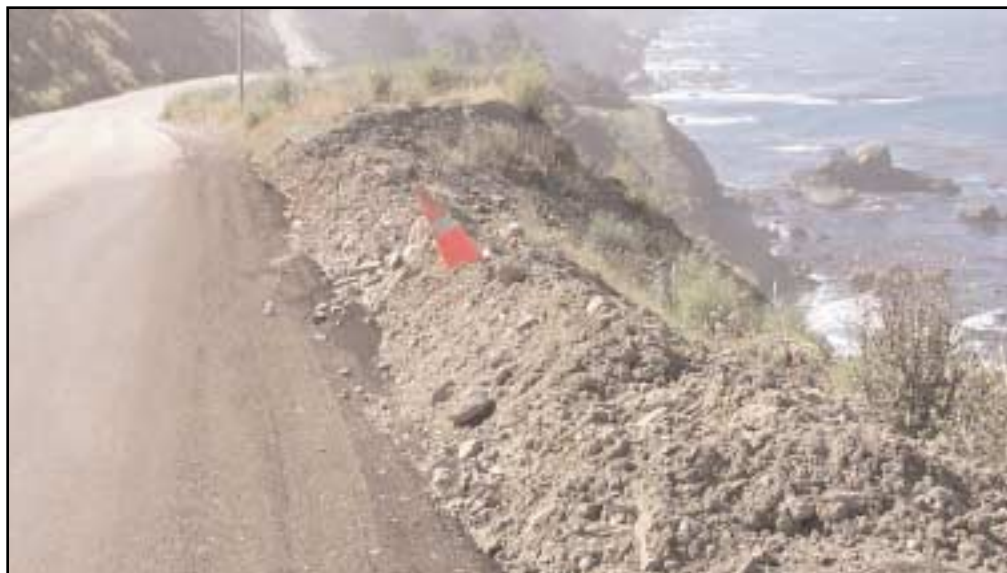
Caltrans Erosion Site Analyses		North Vicente Creek Bridge					
SLO County Line Mile Post Marker	26.2						
Photo-Reference Number	13-01, 13-02, 13-03						
Site Conditions	Highway slumping, overcast soils, no weed control, soil flowing to intertidal zone, phone cable impact						
Habitat Type	Coast scrub						
Soil Type	Decomposed granite						
Slope	40%						
Aspect	West						
Sensitive habitat present	Smiths blue butterfly						
Regional and Neighboring Property Owners	Packard Ranch						
Potential Occurance of Rare Plant and Animal Species							
Eriogonum parvifolium							
Smith's blue butterfly							
Exotic Species Present (threat)							
Foeniculum vulgare, Cotaderia jubata, Silybium marianum							
Potential Occurance of Cultural Artifacts							
none							
<u>POTENTIAL FOR EROSION EVENT</u>		(rank 1-10)	Importance	Urgency	Trend		
			up slope	down slope	up slope	down slope	
Erosion Hazard			0	3	0	3	6

Figure 2.19. Recent road repair and sidecast with little erosion protection.

Site #10 North Vicente Creek Bridge					
Restoration Recommendations					
Site Objective	Erosion Control/ Revegetation	Bio-Engineering Applications	Site Maintenance Actions	Seed and Revegetation	Monitoring Actions
Site Stabilization		Hydroseed and straw	Manage sidecast- Remove material that is piled over two feet high	<i>Mimulus auranticus,</i> <i>Ceanothus thyrsiflorus,</i> <i>Artemisia californica,</i> <i>Bacharris pilularis, Lupinus albafrons</i>	Site stabilized, erosion present?
Revegetation	Upslope requires permanent revegetation mix		Reseeding, planting as required Site requires temporary erosion control on berms		Is site revegetated, species diversity present?
Site Maintenance	Exotic species present: Pampas grass- fennel		Control of exotic species Surface water diversion treatment needed immediately		Weeds controlled, exotic species less than 10% cover
Project Reporting	Required as project element	Report	Site maintenance actions recorded	Submittals review/ specified materials at hand Specified materials not available/ specify alternates	Project completed/success criteria achieved Project not completed- remedial measures required

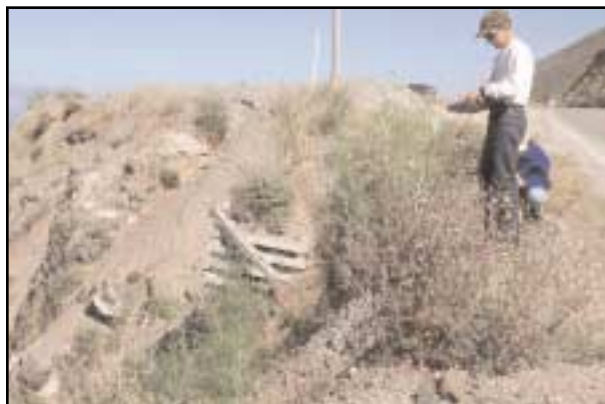
Figure 2.20. Sidecast, unstable soil, and invasive weeds.

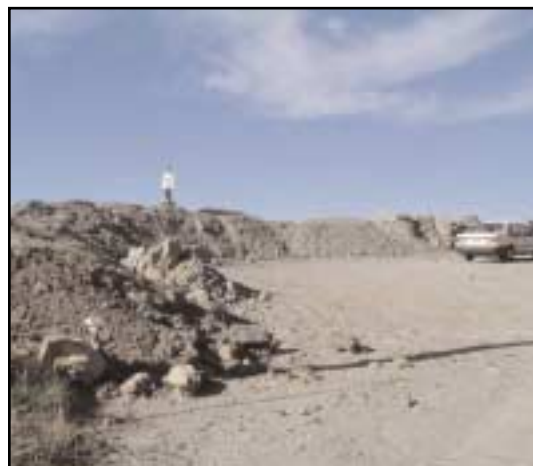
Figure 2.21. Picture taken in early January 2001 shows very high berm obscuring views from the highway and pullout.

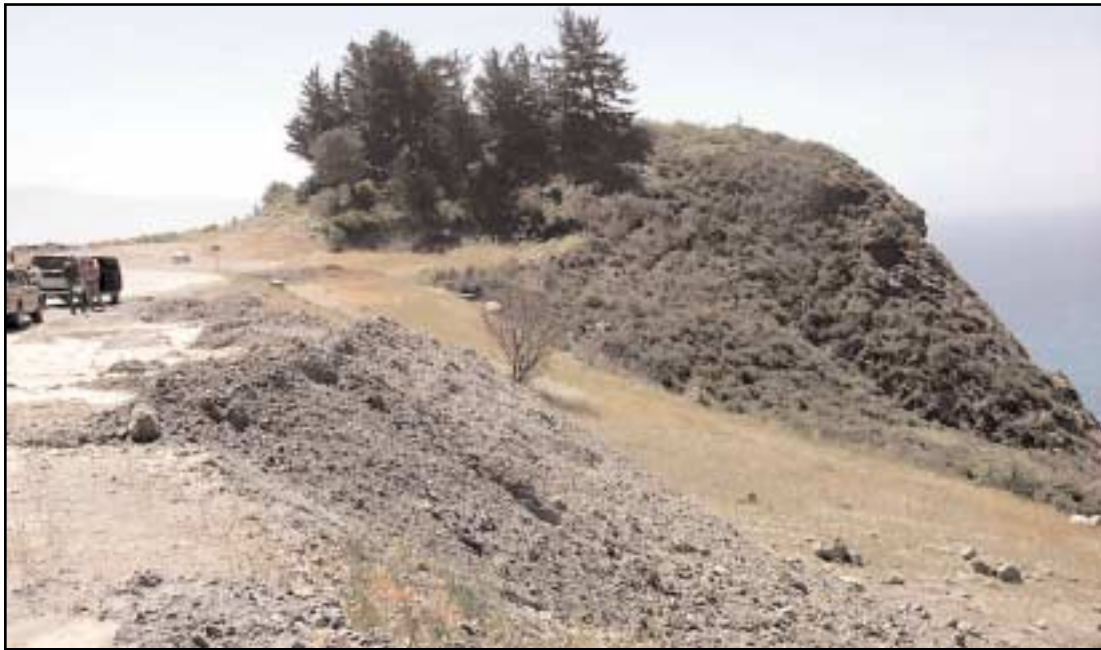
Figure 2.23. Sidecast left in early Spring 2000. As the year progressed, more sidecast was left behind due to road repairs at another location.

Site Objective	Erosion Control/ Revegetation	Bio-Engineering Applications	Site Maintenance Actions	Seed and Revegetation	Monitoring Actions
Site Stabilization	Continue remedial erosion control seeding upslope		Rill and gully erosion repaired	<i>Melica imperfecta</i> , <i>Festuca rubra</i> , <i>Lotus purshianus</i> , <i>Festuca californica</i> , <i>Trifolium gracilentum</i>	Is site stable?
	Anchor toe of slope where slippage occurs downslope		Control surface water flow away from downslope into control structure.		Is erosion present?
Revegetation		Willow pole cuttings in seeps and springs up and down slope		Plant willow poles in wet seeps Plant <i>Eriogonum parvifolium</i> at 48"O.C. revegetation seed mix	Is site revegetated with a diversity of species present?
Site Maintenance		Repair/replace straw wattles upslope	Dry water installation needs to be removed	Use of hydropost top soiling required	Are all non-biodegradable elements removed?

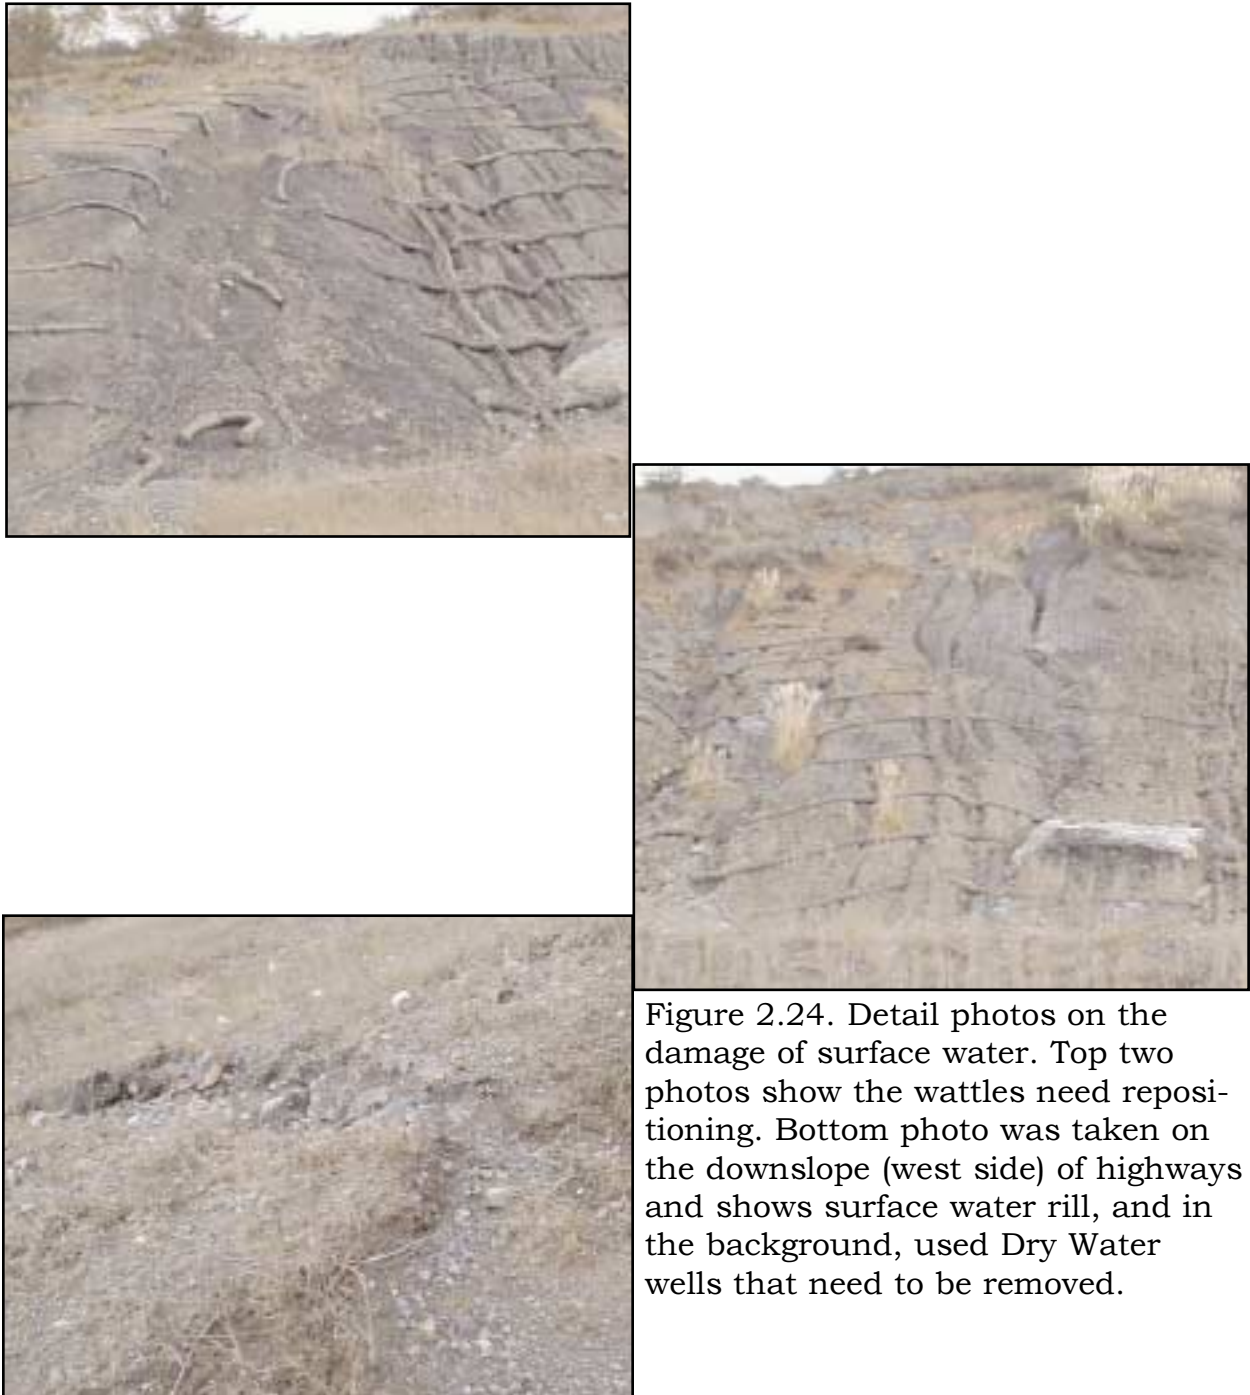
Figure 2.24. Detail photos on the damage of surface water. Top two photos show the wattles need repositioning. Bottom photo was taken on the downslope (west side) of highways and shows surface water rill, and in the background, used Dry Water wells that need to be removed.

There has been an approx. 35% loss of wattles upslope this year due to surface water damage.	Wooden stakes need removal Weed control: Fennel and Pampus grass		Are exotic invasive plant species less than 10% of site coverage?
Project Reporting	No erosion present	Bio-engineering in place and functioning	Site maintenance actions recorded	Submittals review/ specified materials at hand	Project completed, success criteria achieved-Final Recommendations
	Erosion present/ recommendations	Bio-engineering needs remedial repair and/or maintenance		Specified materials not available/ specify alternates	Project not completed-remedial measures required

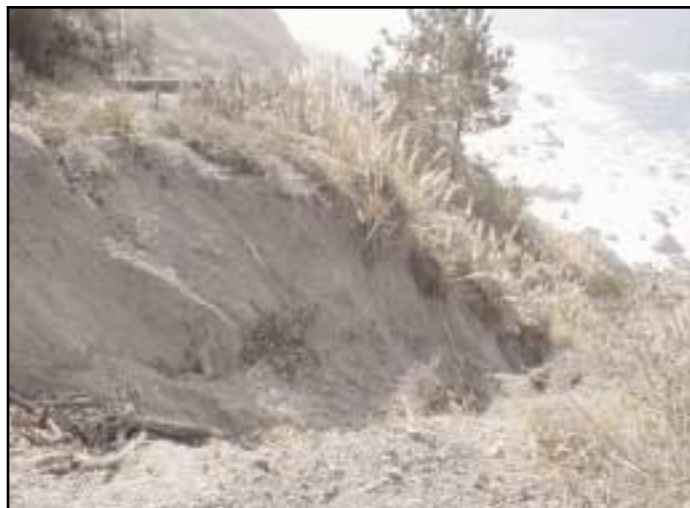
Figure 2.26. Looking downslope facing south. View of large unvegetated gully.

Site # 15 Willow Springs					
Restoration Recommendations					
Site Objective	Erosion Control/ Revegetation	Bio-Engineering Applications	Site Maintenance Actions	Seed and Revegetation	Monitoring Actions
Site Stabilization	Needs permanent berm treatment downslope		Erosion control gullies and rills repaired downslope	<i>Salvia mellifera, Bromus carinatus, Eriophyllum steachadipolium, Eriogonum parvifolium</i>	Site stabilized, erosion present?
			Needs surface water diversion on downslope to control structure	Temporary erosion control before October 15th	No impact to sensitive habitat?
Revegetation	Downslope requires permanent revegetation mix-berm requires permanent berm seed mix	Willow wattles in wet gullies	Reseeding, planting as required		Is site revegetated, species diversity present?
Site Maintenance	Exotic species present: Pampas grass, Eucalyptus trees	Inspect and repair bio- engineering features (stakes removed)	Control of exotic species- Eucalyptus sprouts will need remedial spraying with Garlon	Reseed if native plant composition fails to replicate native habitat downslope	Weeds controlled, exotic species less than 10% cover

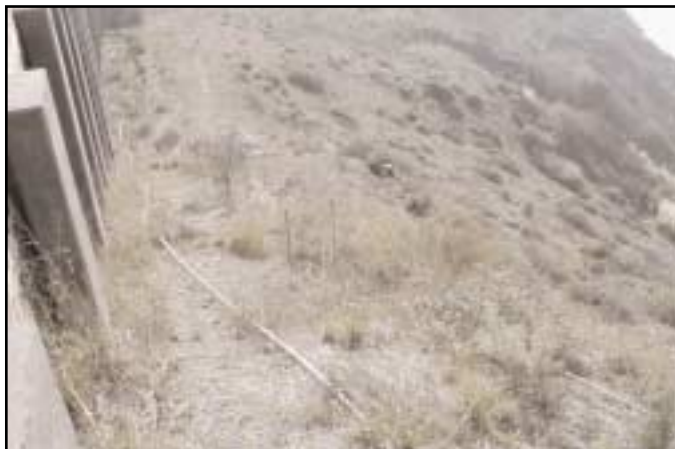
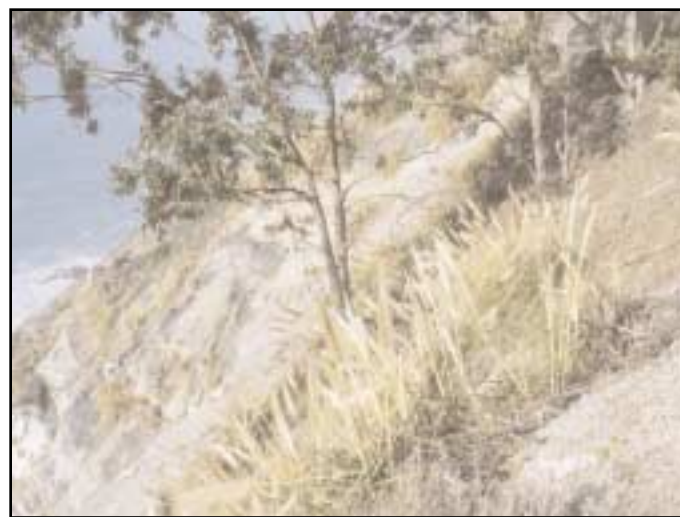
Figure 2.27. Looking downslope facing south near road structure. Note irrigation lines, rebar, and other materials that may need removal. Vegetation seems well established at this previous restoration site.

Figure 2.28. Looking downslope and north showing bare soil, eucalyptus and pampas grass.

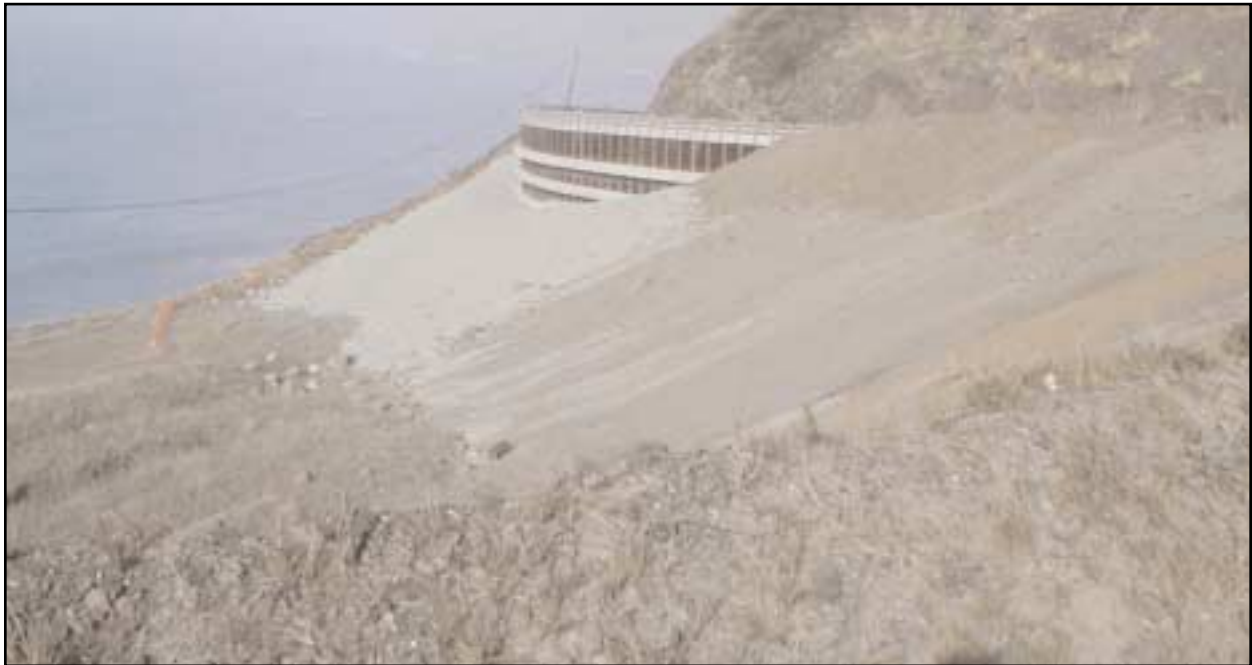
Figure 2.30. Site photo showing storage of loose soil material. Revegetation work needs to continue to stop surface erosion.

Site # 16 Gray Slip					
Restoration Recommendations					
Site Objective	Erosion Control/ Revegetation	Bio-Engineering Applications	Site Maintenance Actions	Seed and Revegetation	Monitoring Actions
Site Stabilization	Needs permanent berm treatment up and downslope		Erosion control gullies repaired upslope	<i>Lupinus arboreus abramsii</i> , <i>stachys bulata</i> , <i>Lotus pursianus</i> , <i>Salix sitchensis</i>	Site stabilized, erosion present?
				Temporary erosion control before October 15th	Berm revegetated?
Revegetation	Plant willows along water drainages(sitka willow) upslope		Reseeding, planting as required	Revegetate with legume plants upslope	Is site revegetated, species diversity present?
			Remedial site regrading may be required upslope		
Site Maintenance	Exotic species present up and downslope		Control of exotic species	Reseed if native plant composition fails to replicate native habitat throughout site	Weeds controlled, exotic species less than 10% cover

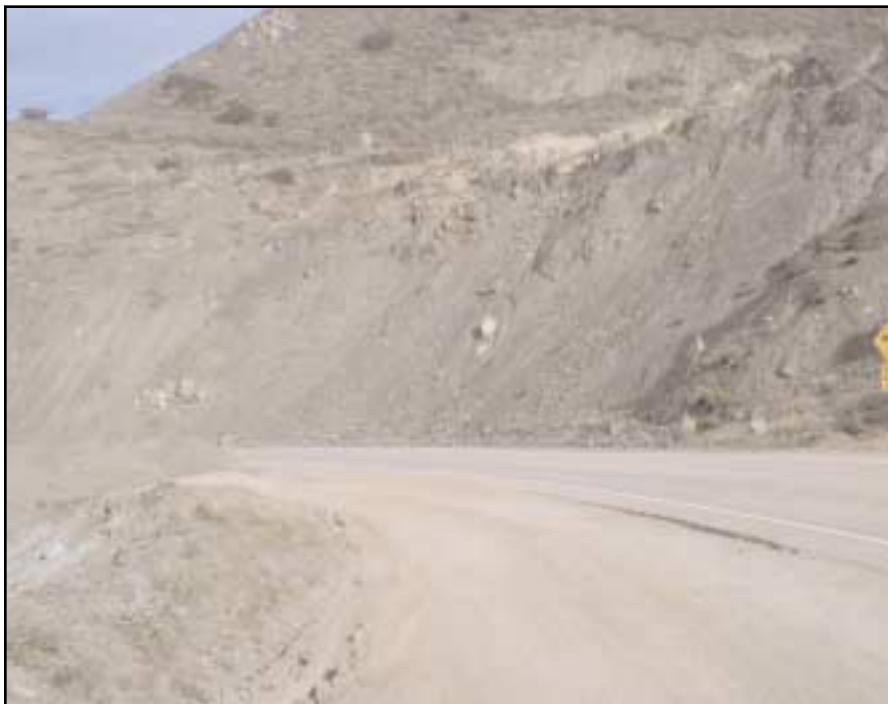
Figure 2.31. gray slip upslope showing bare slope.

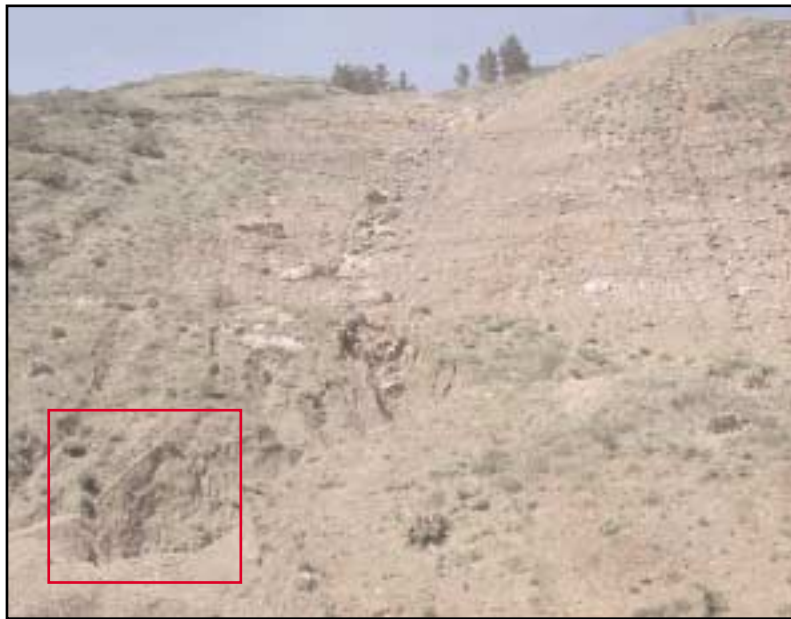
Caltrans Erosion Site Analyses		Redwood Gulch						
SLO County Line Mile Post Marker	5.2							
Photo-Reference Number	6-01, 6-02, 6-03							
Site Conditions	upslope large landslide							
Habitat Type	Central Coast Scrub, Redwood, Riparian							
Soil Type	Decomposed granite							
Slope	100%							
Aspect	West/Southwest							
Sensitive habitat present	Redwood forest, Riparian							
Regional and Neighboring Property Owners								
Eric Jensen, USFS								
Potential Occurance of Rare Plant and Animal Species								
Riparian draws, Red-legged frog, Steelhead trout, pond turtle								
Exotic Species Present (threat)								
Cortaderia jubata, Foeniculum vulgare								
Potential Occurance of Cultural Artifacts								
none								
<u>POTENTIAL FOR EROSION EVENT</u>		<u>(rank 1-10)</u>	<u>Importance</u>		<u>Urgency</u>		<u>Trend</u>	
			<u>up slope</u>	<u>down slope</u>	<u>up slope</u>	<u>down slope</u>	<u>up slope</u>	<u>down slope</u>

Figure 2.33. This site is large in scale. The top photo pictures the upslope, and the boxed area is shown enlarged in the bottom photo.

Site # 17 Redwood Gulch					
Site Objective	Restoration Recommendations				
	Erosion Control/ Revegetation	Bio-Engineering Applications	Site Maintenance Actions	Seed and Revegetation	Monitoring Actions
Site Stabilization				<i>Nassella lepida, Lotus purshianus, Melica imperfecta, Lupinus benthamii, Baccahris pilukarus</i>	Is site stable?
Revegetation	Permanent berm vegetation on West side of road		Exotic species exceed 10% cover-remedial measures required		Is erosion present? Is site revegetated with a diversity of species present? Monitor gully on upslope face
Site Maintenance			Exotic species controlled Downslope exotic species control		Monitor culvert under road for blockage Are exotic invasive plant species less than 10% of site coverage?
Project Reporting	No erosion present Erosion present/		Site maintenance actions recorded	Submittals review/ specified materials at hand Specified materials not	Project completed, success criteria achieved-Final Recommendations Project not completed-

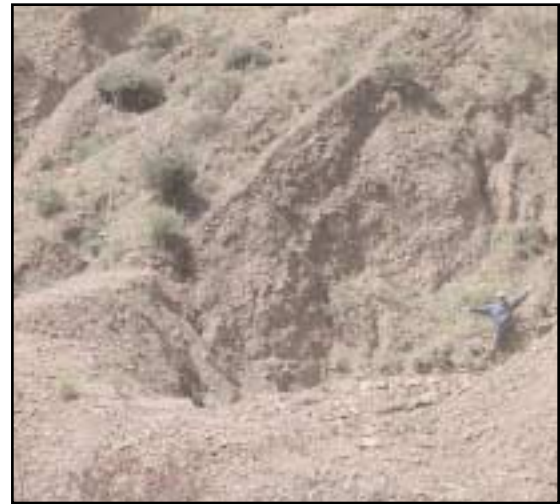
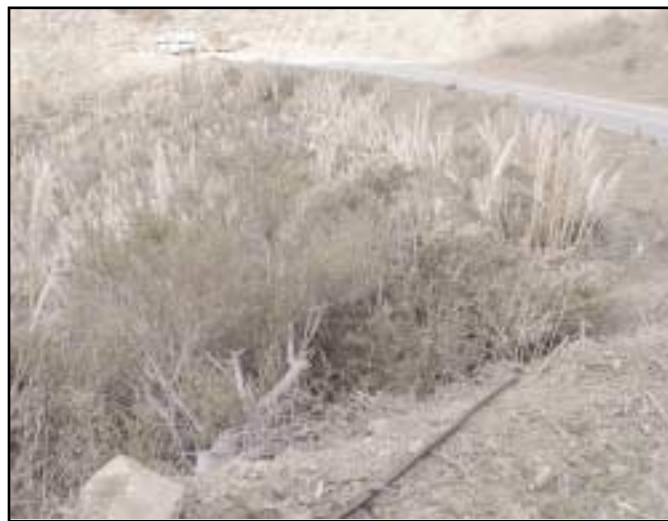
Figure 2.34. Redwood Gulch downslope looking north. Note pampas grass and old irrigation line.

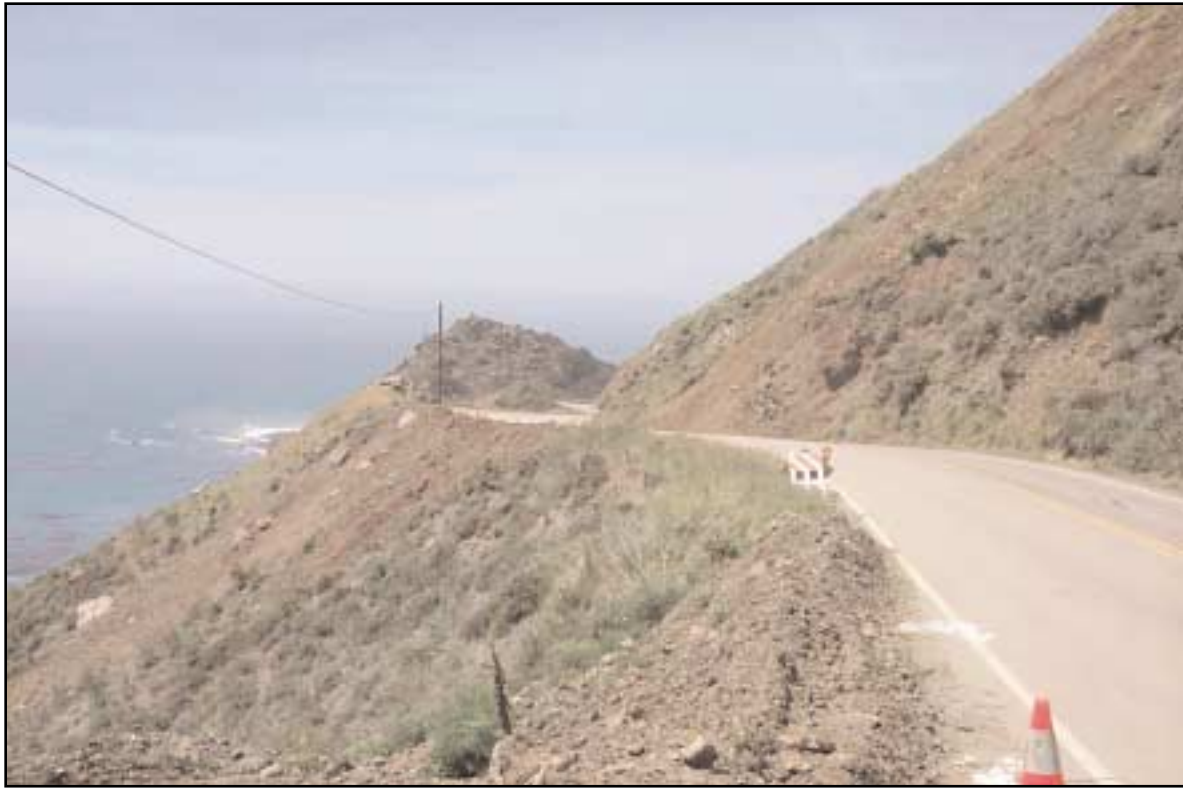
Figure 2.36. Slope pictured from Spring, 2000. Slope continued to erode until it closed the south bound lane. Roadway is under construction currently.

Table 2.21. Restoration Recommendations for Salmon Creek South. Shortly after this site was surveyed for this report, the western downslope gave way and closed the south-bound lane. A previous restoration effort near the site managed to stay stable. This older site should be regarded as a template for the current site, using jute netting and hydroseeding with the seed mix in the Table.

Site #18 Salmon Creek South - Site is currently under construction due to downslope failure					
Restoration Recommendations					
Site Objective	Erosion Control/ Revegetation	Bio-Engineering Applications	Site Maintenance Actions	Seed and Revegetation	Monitoring Actions
Site Stabilization	Temporary erosion control vegetation after construction downslope		Slope failure downslope - needs soil stabilization	Permanent revegetation not appropriate until site stabilized downslope. <i>Leymus condensatus, Melica imperfecta, Festuca rubra, Artemisia californica, Eriophyllum steachadifolium</i>	Is site stable? Is erosion present?
Revegetation		Jute netting and hydroseed downslope.	Site immediately south (at the Southern signal light) was a successful restoration downslope. Project is stable with good diversity of plants. Use as model.	Revegetate with temporary seed mix until downslope stable.	Did site revegetate?
